SI Number: SI-NR0005 Factory Ref: PAPTH1604005TE

Model(s): NR-BW415, NR-W465, NR-BY552, NR-CY557

Subject: Interior LED does not operate

Issue Date: 11th April 2016 Page: 1 of 2

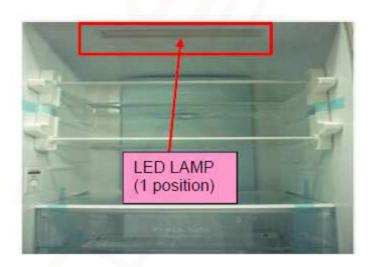
NR-BW415, There is only 1 LED lamp on the ceiling of the inner.

NR-BW465: Exchange both 1 LED PCB & Cover LED before Serial no :6xx4xxxxx(The

kit of 1 LED PCB and 1 cover is available.)

Measure: Replacement of LED PCB with kit

Model	Part Name	Part N°.	Contents of Kit
NR-BW415,	PAS-BW(LED PCB)-		LED PCB: 1 pcs
NR-BW465	Kits	CNRBG181513W	COVER LED LAMP: 1 pcs
